Structural Foundation & Crawl Space Evaluation Report

1234 Main St, Livermore, CA, 94550

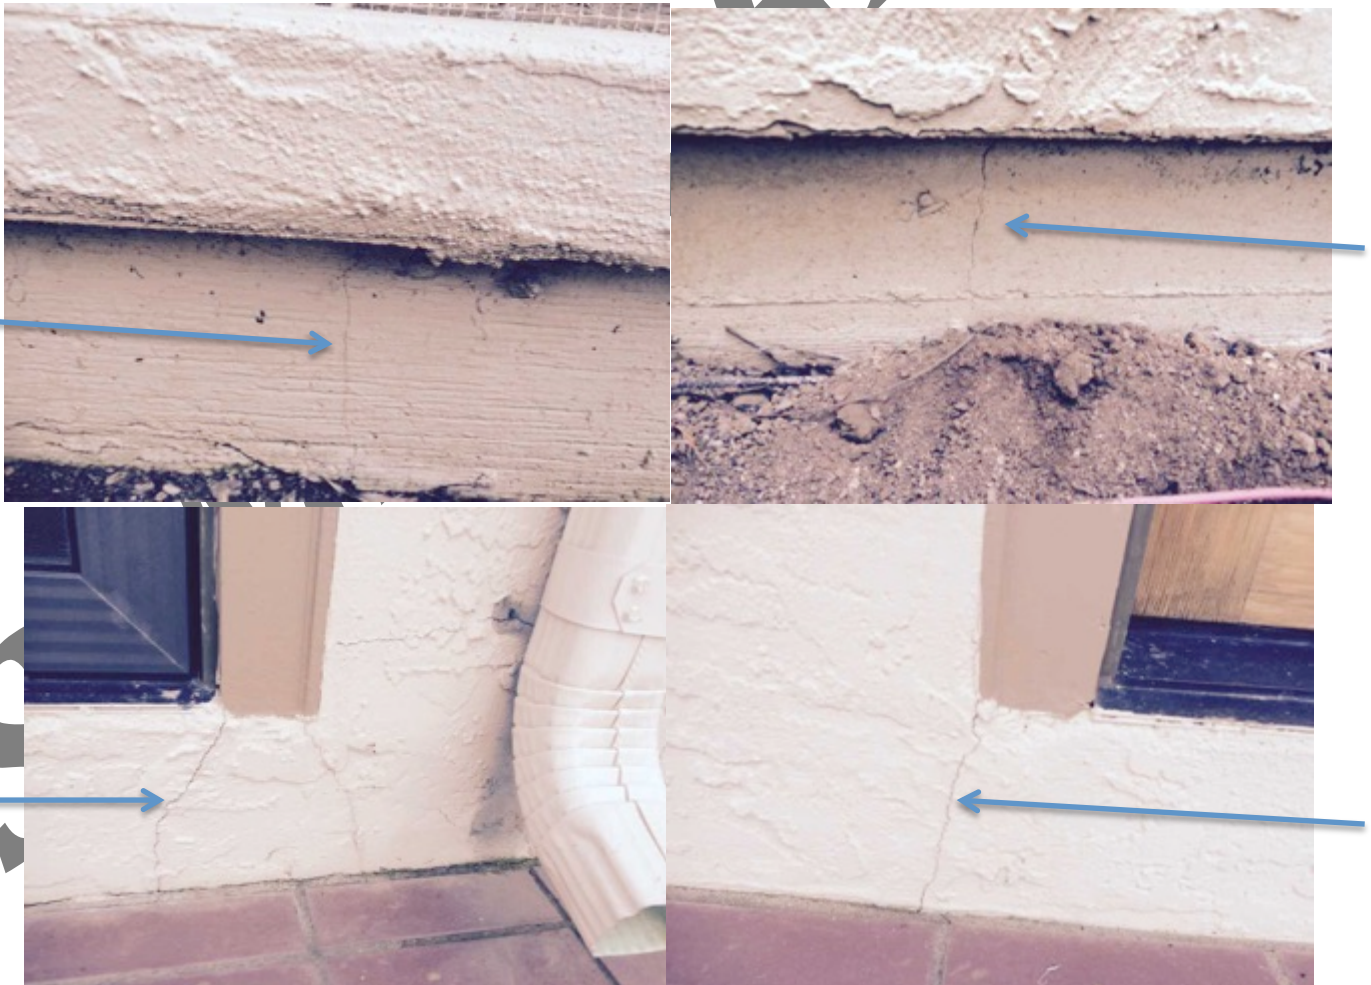
A visual inspection of the raised concrete perimeter foundation around the exterior perimeter of the house showed only a small portion of the exterior foundation wall area to be visible due to the stucco siding extending down over the raised foundation walls. Two hairline vertical cracks were noted in the raised foundation wall (one at the east side and one at the west side of the home). These two cracks are thin and are not compromising the structural integrity of the foundation. It is recommended to seal these two cracks with an epoxy to help seal from moisture intrusion, which can then be painted over to match the existing siding color. Cracking in the stucco siding was also noted around some of the corners of windows and doors. Please note that the following is only some, not all, of the cracks observed on the exterior portion of the house. (Please see [blue](#) arrows and pictures below)

The thin vertical cracks seen on the exterior of the home should be sealed with an epoxy to help stop moisture intrusion which can make the rebar within the concrete rust and or expand and contract which can lead to more cracking.

- Install push piers around the portions of the raised foundation perimeter wall to cover the low elevation areas seen outside of industry standard which will stabilize and protect the structure from further settlement in those areas.
- Install epoxy to all thin vertical cracks on exterior raised foundation wall.
- It is recommended to have a structural engineer perform a conditions report in addition to this Evaluation Report due to the piercing recommendation. Any piercing installations require a third party structural engineer to perform a conditions report to create calculations and drawings to be submitted to the city for permitting.

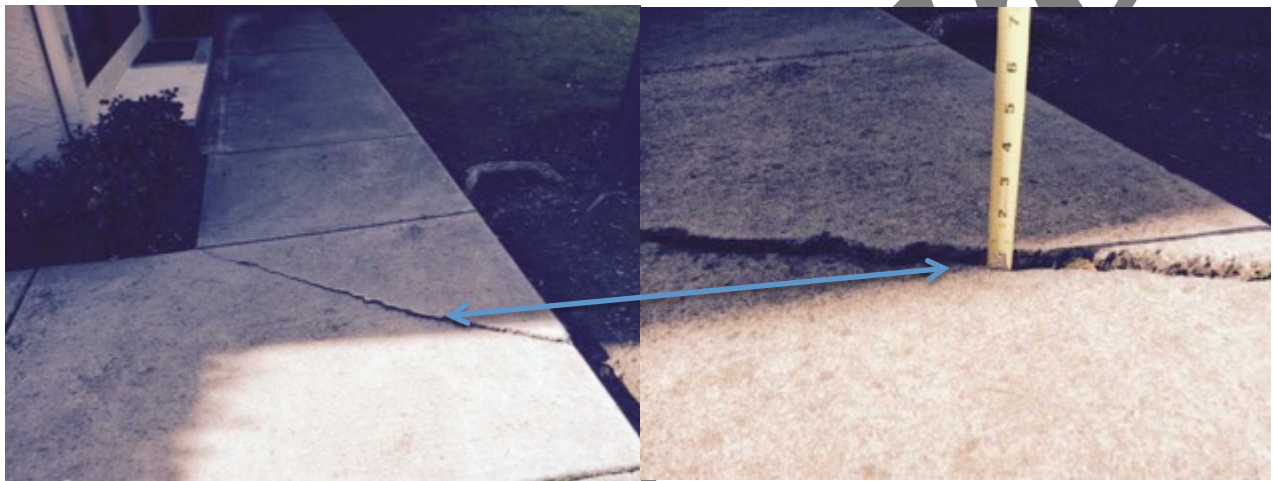
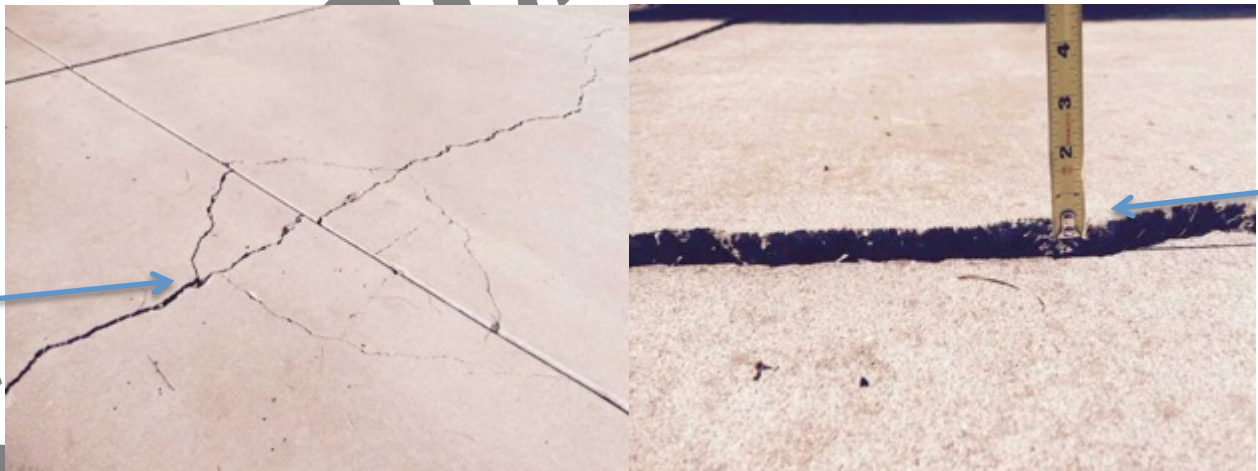
The properties concrete perimeter driveway, walk-ways showed some signs of notable cracking with some potential tripping hazards present at the side driveway due to the areas concrete slab displacement from settlement. It is recommended to seal all cracks to help stop water intrusion which can undermine the soil under the concrete slabs. It is also recommended to monitor the sections with displacement to see if the potential tripping hazards become more pronounced over to time. Some form of concrete restoration through polyurethane foam injection could lift these areas to minimize the potential tripping hazards as one possible solution. (Please see blue arrows and pictures below)

The properties concrete perimeter driveway, walk-ways and back patio that showed signs of notable cracking with a potential tripping hazard present at the walkway due to the areas concrete slab displacement from settlement could be restored by sealing all cracks and lifting the concrete with a polyurethane foam injection.

- Inject polyurethane foam under displaced slabs to minimize surface height differences to reduce tripping hazards and seal all cracks to help stop potential water intrusion.

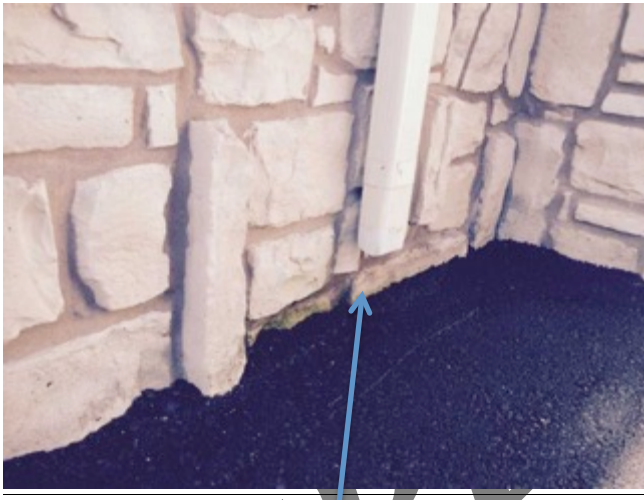
Land topology around the property's immediate foundation perimeter is mostly flat with the exception of the south garage wall that has the hillside sloping away from the home. An exterior water drainage system for the down spouts such as being buried with extensions to divert water away from the foundation was present for all but 1 of the downspouts. It is recommended to maintain the water drainage extensions connected to all down spouts to divert the water at minimum 10 feet away from the foundation perimeter, not allow for leakage, and to keep the gutter system maintained. Water pouring out of the downspouts without proper water drainage or having a slope in the ground that leads down towards the home will allow the water to be directed in an area that could help compromise the soil around the perimeter of the foundation, which can contribute to water intrusion and structural settlement issues. (Please see [blue](#) arrows and pictures below)

Downspout without drainage extension

- Keep rain gutters, downspouts, and drain lines clean and properly connected without leakage directed at least 10 feet away from the foundation perimeter to lower areas of the property away from the home.
- Monitor foundation and sub floor conditions for changes every three years by a qualified professional.
- Maintain proper function of existing interior and exterior drain and plumbing lines to not allow for water leaks.
- Homes with crawl spaces should be monitored annually and after rain fall for any signs of moisture, direct water intrusion, or water leaks.
- Implement a professional pest control program per residential standards to help maintain all wood subfloor and framing systems.

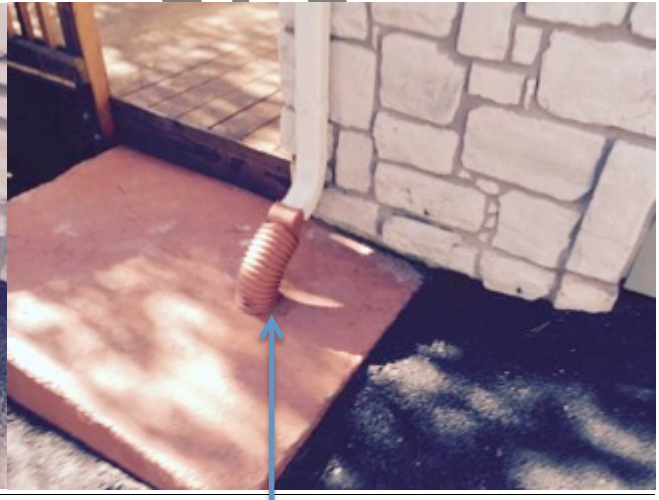
Downspout with drainage extension

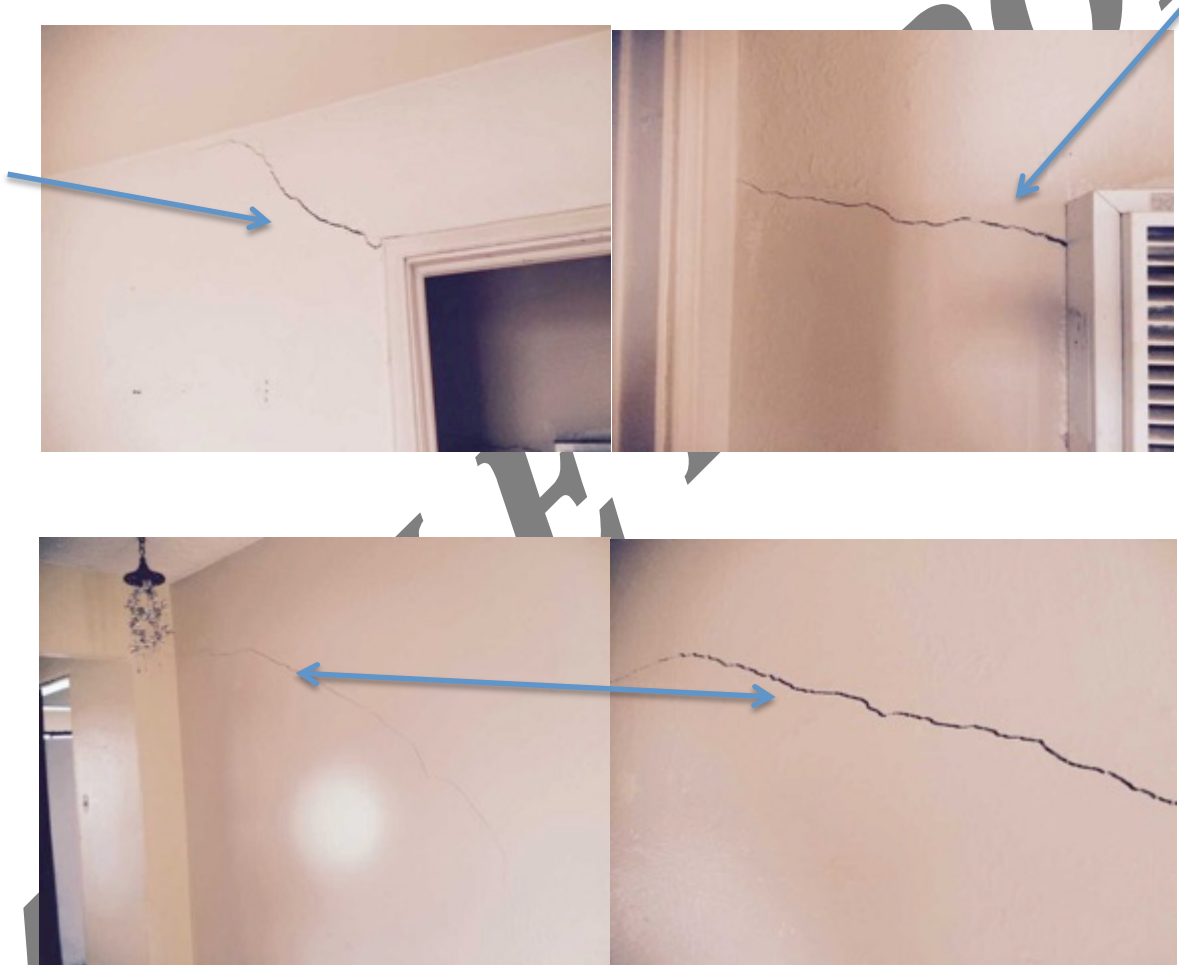
Dry wall cracking and separation of materials was observed on the interior portion of the home at the time of the evaluation as seen in the photos below. Note that the following is only some, not all, of the cracks and separation of materials observed on the interior portion of the house. (Please see [blue](#) arrows and pictures below)

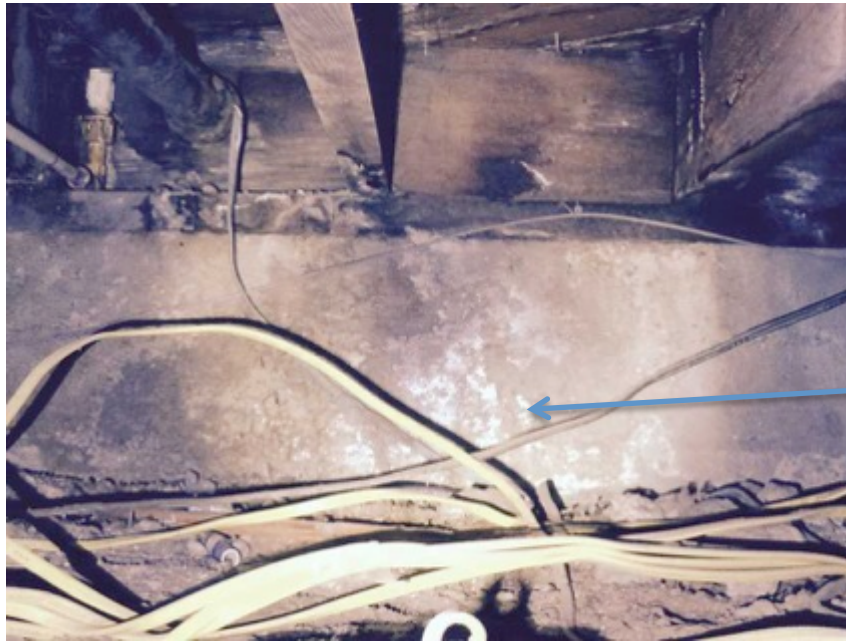
The interior portion of the raised concrete foundation wall that was visible from the crawl space showed it at some point had a moderate level of moisture with mineral deposits (efflorescence caused as humidity/ moisture dries leaving a white crystallization). The crawl space area was dry along the exterior foundation wall and interior portions at the time of the evaluation.

It was not raining at the time of the evaluation and, therefore, it could not be determined with certainty if water would enter the crawl space at any other points or pool at any localized low areas around the property. (Please see [blue](#) arrow and picture below)

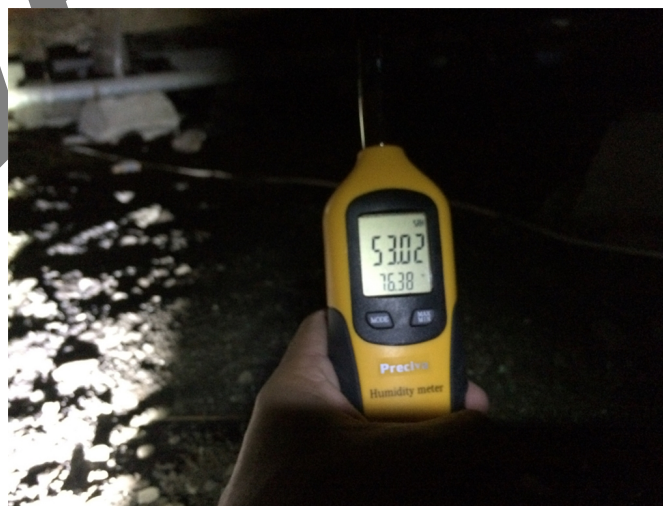
The relative humidity level in the crawl space was recorded at 53% using a hygrometer. Permanently maintaining a relative humidity level less than 60% inhibits fungal growth.

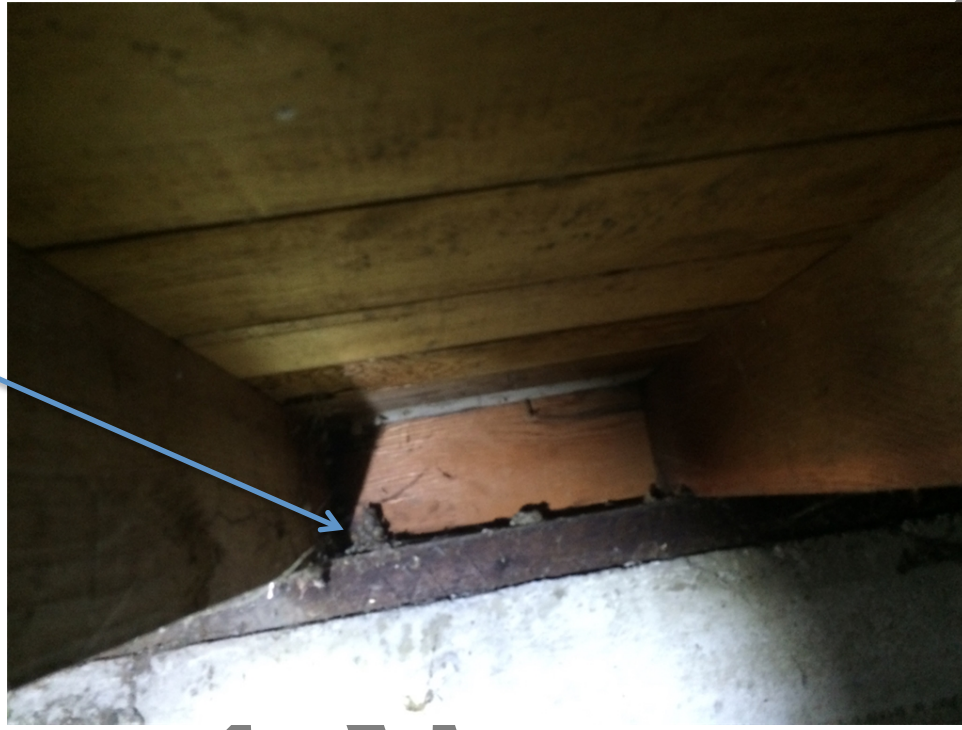
**Foundation
Anchor Bolt**

Foundation anchorage with anchor bolting was adequate and noted throughout sections of the crawl space.

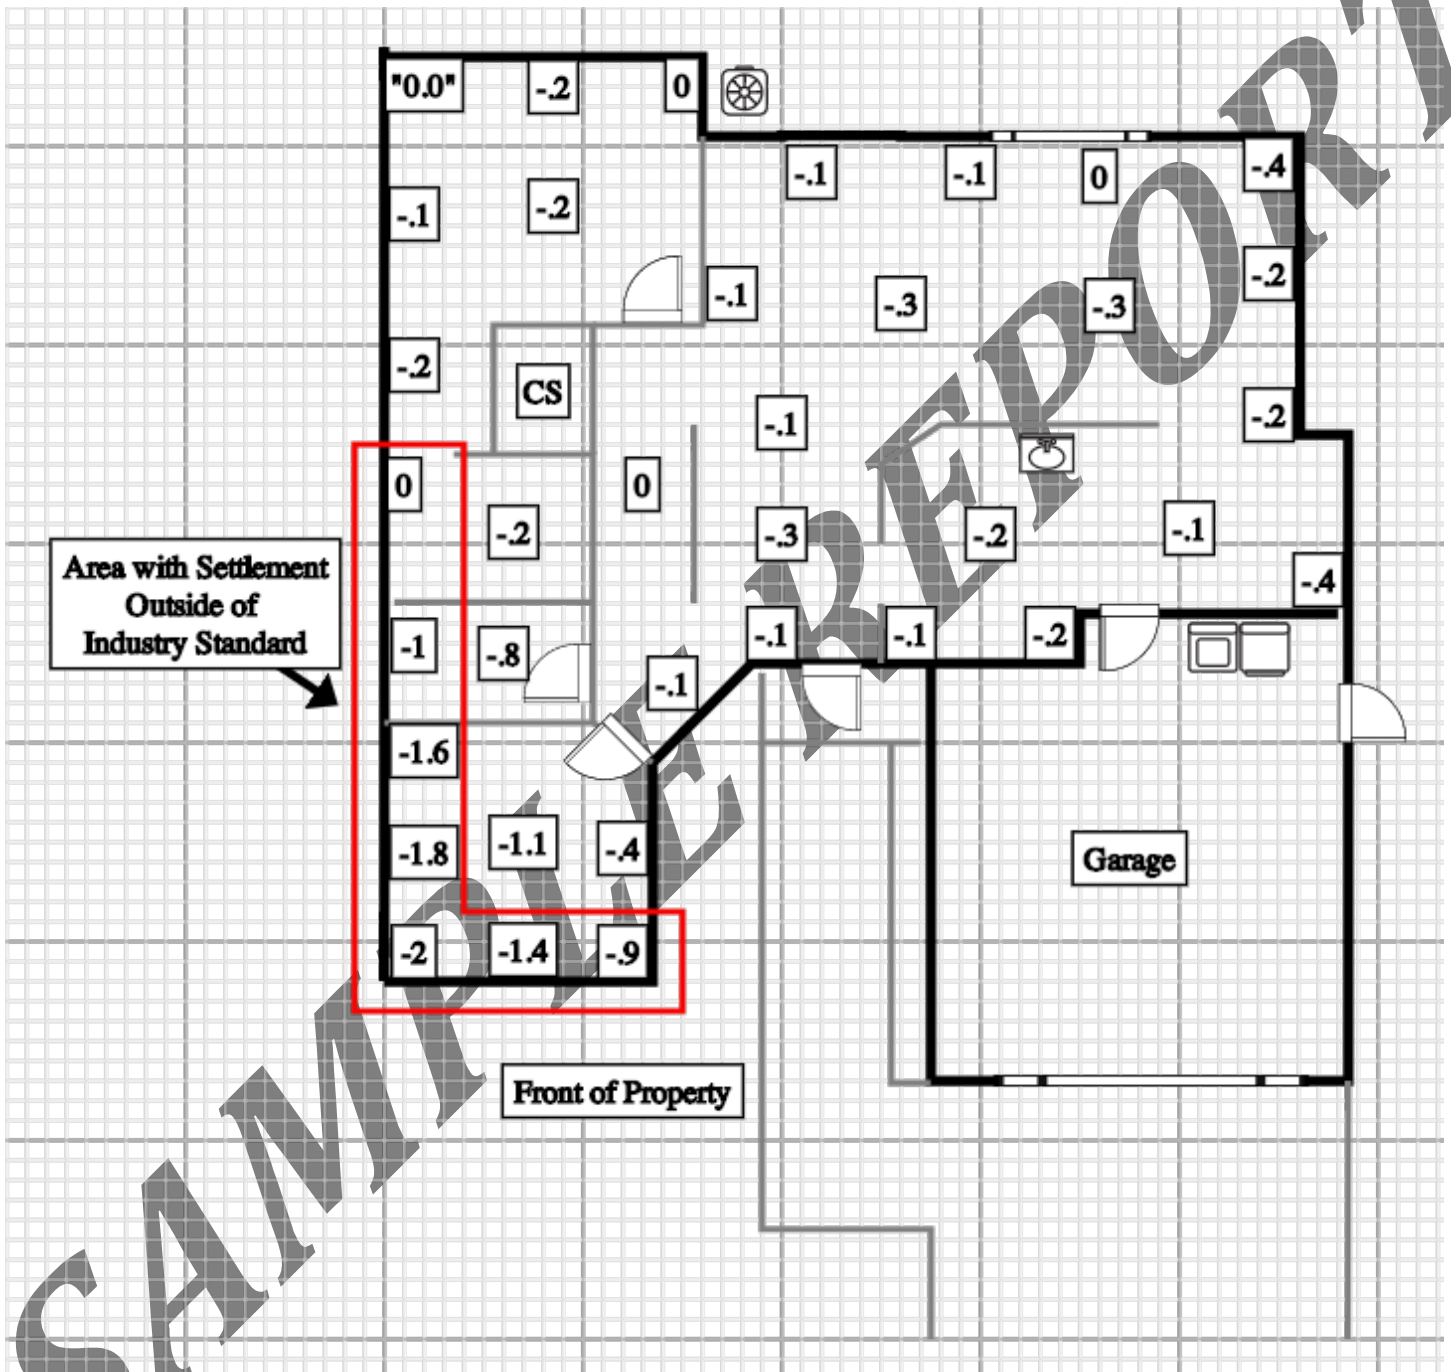
Elevation Survey (Figure A)

A high precision altimeter elevation survey was performed on the interior floor of the subject property, using the foundation perimeter as the bench mark or starting point; designated as "0.0" on the floor plan (Figure A). Measurements of the floor elevation were made in tenths of an inch. The highest elevation reading recorded was 0 inches while the lowest point was -2 inches. The maximum difference in the floor elevation readings was 2 inches. Center portions of the home supported by the pier post assemblies and girder system were generally in line with the perimeter measurements and no major changes in elevation were noted.

The structure and foundation is showing signs of differential settlement. For example the span between the "0.0" elevation reading to -2" seen going from north to south on the foundation perimeter on the west wall of the bedrooms and bathroom had a 2" elevation drop over 17 linear feet.

Deep foundation stabilization or lifting through underpinning with push piers would be recommended to stop further settlement in this area and all other areas seen to be sinking. Any visual signs of potential additional settlement should be monitored over time in the future to see if there is any further progression. Other areas of the home should be monitored closely with the amount of settlement already seen.
